Manhole Inspection Summary

Manhole # S17SS1002MH

Insp Date: **5/23/07 1:57 PM**

Location Address: **CYLBURN AVE**

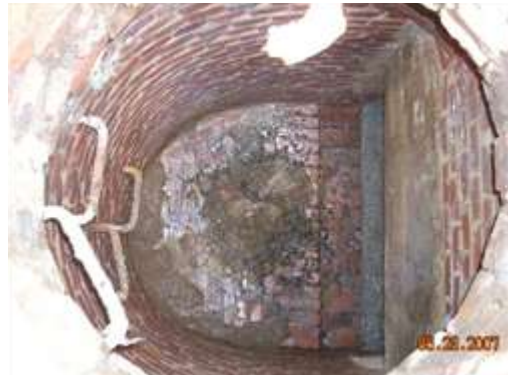
Top View

Corroded steps. Evidence of surcharge - Bench debris.

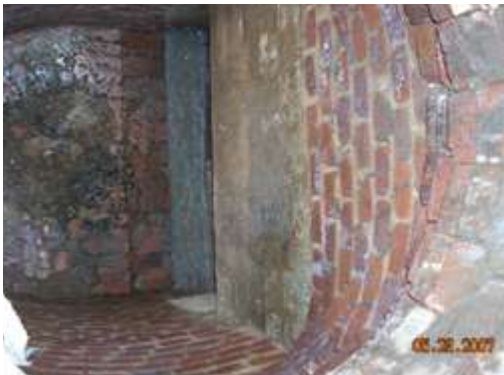
Defect

Adjustment deterioration and infiltration. Barrel infiltration.

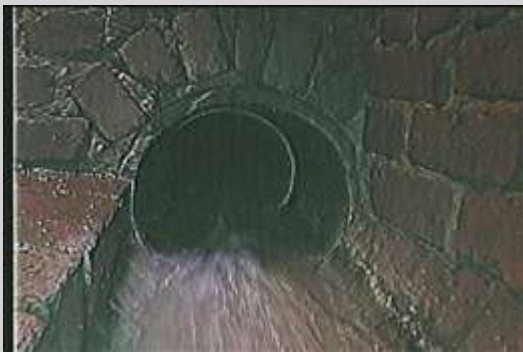
10 in. Circular Gravity Sewer Pipe Out @ 12 O'Clock

Barrel deterioration and infiltration. Channel deterioration.

Infiltration: **None** Pipe Seal Cond: **Broken**

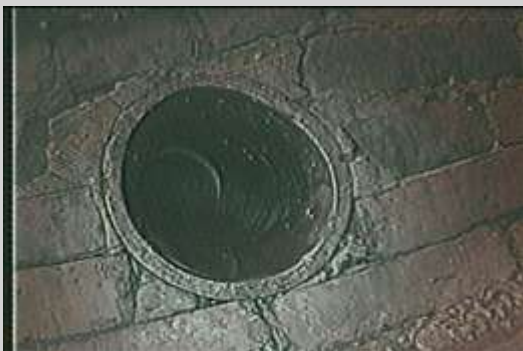
6 in. Circular Gravity Sewer Pipe In @ 3 O'Clock

Infiltration: **Evidence** Pipe Seal Cond: **Cracked**

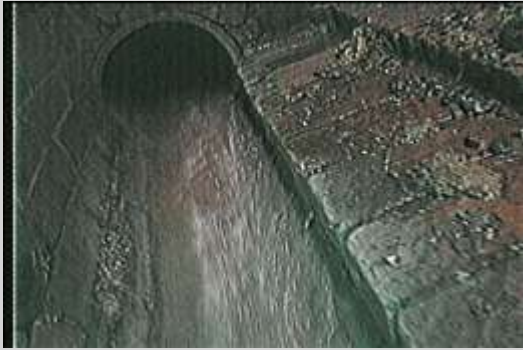
10 in. Circular Gravity Sewer

Barrel deterioration and infiltration. Channel deterioration.

Infiltration: **Evidence** Pipe Seal Cond: **Cracked**
